ANNEXES

ANNEX A: INCIDENT REPORT AND THE RESPONSE OF THE PLA

DOVE PIER: COPY OF INCIDENT REPORT

Water Safety Code Incident Report Form

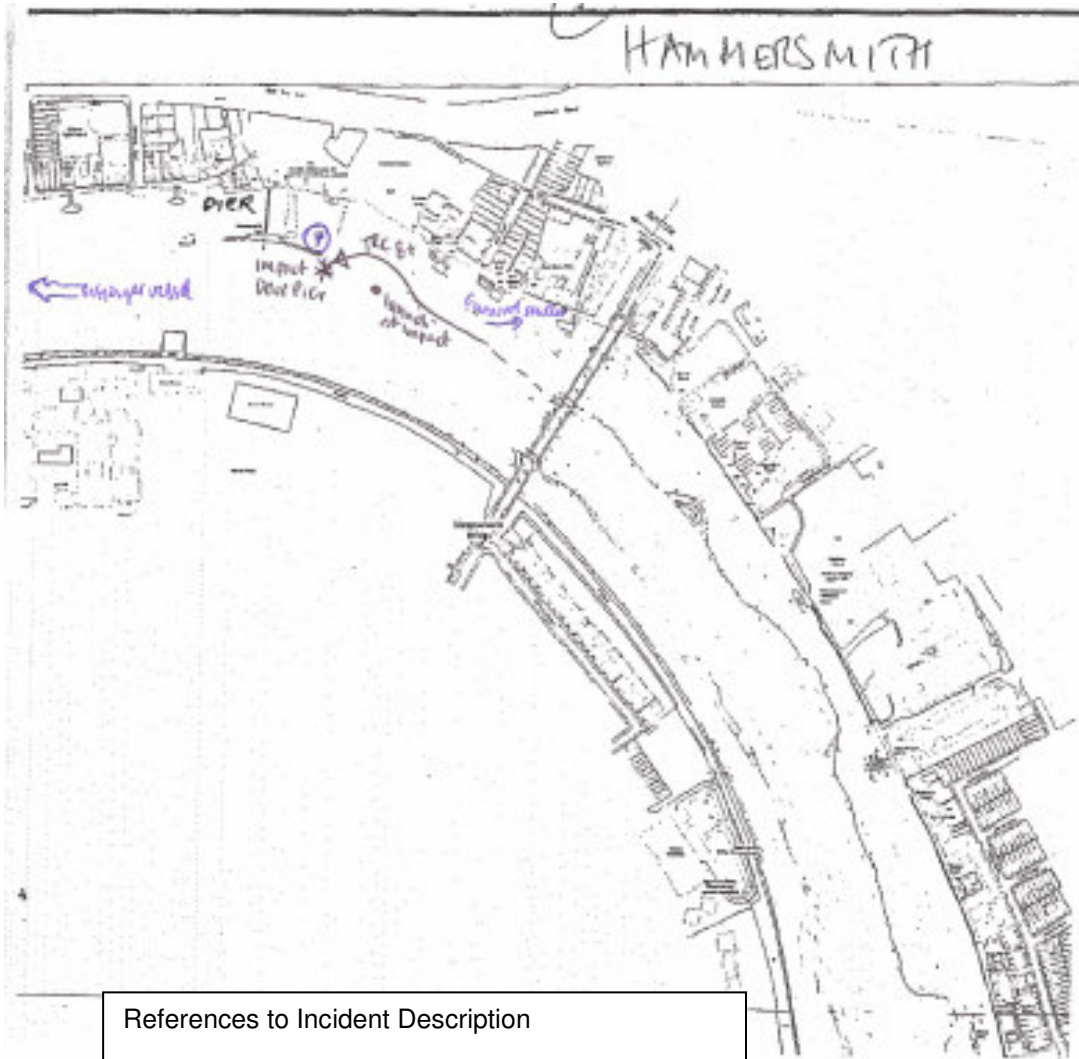
References to Incident Description

2. TRC 8+ was between to the right of the fairway and followed by coach launch approximately 20m behind.
3. The 8+ and coach launch altered course to starboard to allow passage of a large ferry vessel approaching at speed on the fairway from behind. The ferry vessel overtook the TRC 8+ between a position under and 30 metres past Hammersmith Bridge.

4. The TRC 8+ and coachboat commenced recorection of course toward the fairway. This was interrupted by altering course to avoid that of an on-coming IX with Furnival blades and male sculler which was proceeding in a diagonal direction against the stream presumably towards Furnival RC.

5. The TRC 8+ moved further toward the Middlesex side to avoid collision as the IX closed on its diagonal course. The Furnival IX crossed between the path of the TRC 8+ and the coach launch. The launch was at this point approximately 30m diagonally to the rear and port side of the 8+.

6. The TRC 8+ was by now far to the right of the fairway and between 30 to 40m of the Hammersmith shoreline near Auriol Kensington club, stopped rowing per instruction of coach in charge and started to turn its direction towards the centre of the river.

- (3) 8+ alters direction for river vessel
- (4)(5) 8+ alters direction for Furnivall sculler
- (6) 8+ stops

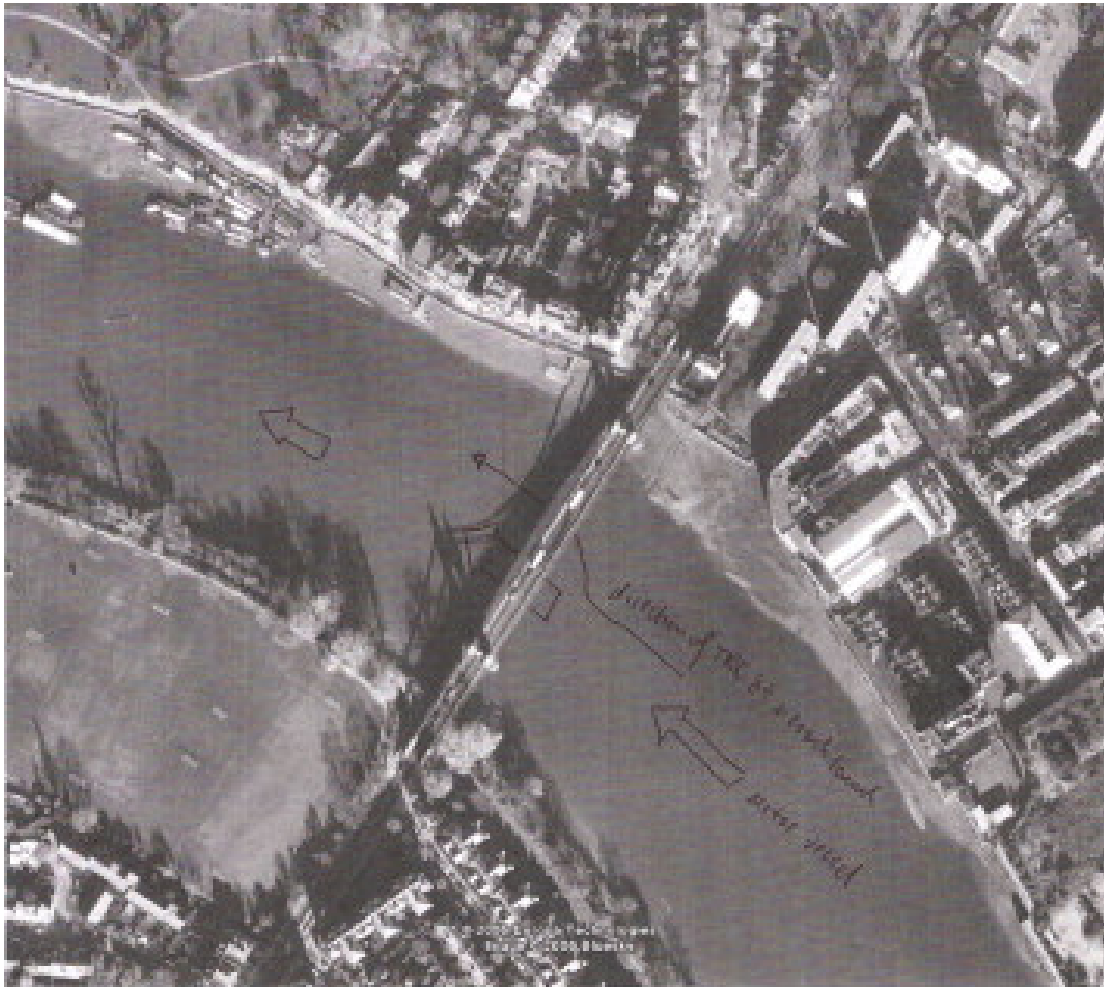
7. The TRC 8+ recommenced rowing following the instruction to do so but did not move fast enough to avoid being pulled towards Dove Pier. The TRC 8+ struck the "Amethyst" which was the left-most (Surrey side) of two Barges at Dove Pier, first striking with its 1 and then 3 blades on the Starboard side of the 8+. The current then swung the 8+ across the second of the two barges (that on Middlesex side) as rowers fought to keep the 8+ righted.

8. The coach launch closed to attempt to pull the 8+ off and to otherwise attend to the crew. The 8+ rolled outwards and crumpled from the bow and stern dropping the crew into the water as it did so. The three sections of the 8+ by this time were separating and the bow section and rower traversed the Surry side of one barge while the stern section broke away and traversed the Middlesex side of the other barge with the stroke rower and coxswain. The remaining rowers fell with their boat and with the boat were swept by the fast current into and under the section between the two barges and the Pier.

References to Incident Description
(7) Impact with Dove pier
