ANNEXES

ANNEX A: INCIDENT REPORT AND THE RESPONSE OF THE PLA

DOVE PIER: COPY OF INCIDENT REPORT

Water Safety Code Incident Report Form

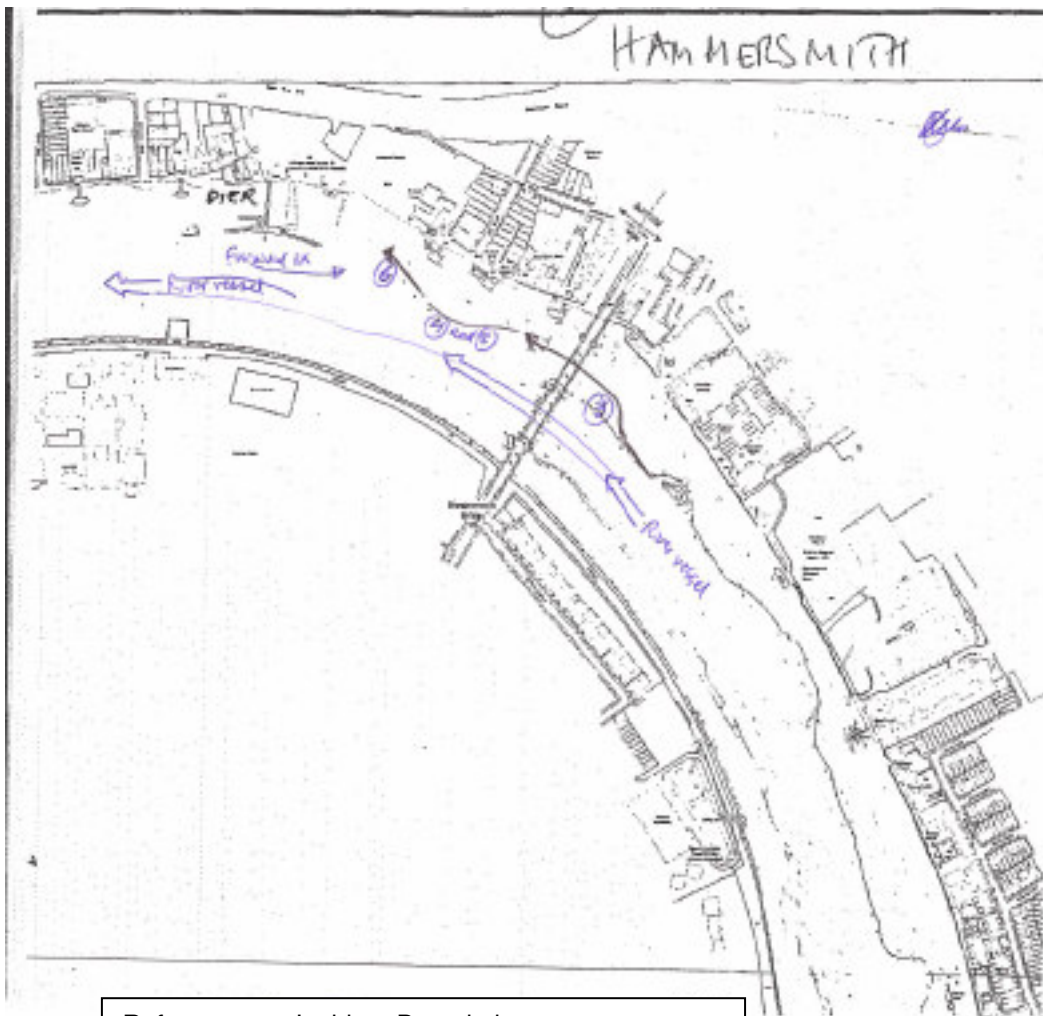
References to Incident Description

- (3) 8+ alters direction for river vessel
- (4)(5) 8+ alters direction for Furnivall sculler
- (6) 8+ stops
